## Case Report Article

# Reestablishing aesthetic and function of patient with severe worn dentition: a conservative approach with provisional fixed tooth/implant supported prosthesis

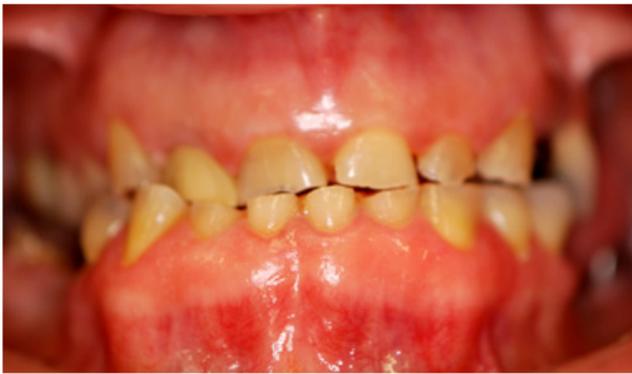
**Figure 1** - Initial condition (front view) showing worn dentition and collapsed occlusion

Patient MVN, male, 55 year-old, presented to the dental clinic of the University complaining of severe teeth wear, difficulty to chew, esthetical impairment and thermal tooth sensitivity (figure 1). The patient also expressed a desire to put prosthetics on implants that had been installed for more than 18 months ago. However, he expressed financial concerns. At the anamnesis, the patient reported being wheelchair user due to automotive accidents and to have a history of hiatal hernia. Furthermore, it was found that the patient had bruxism.

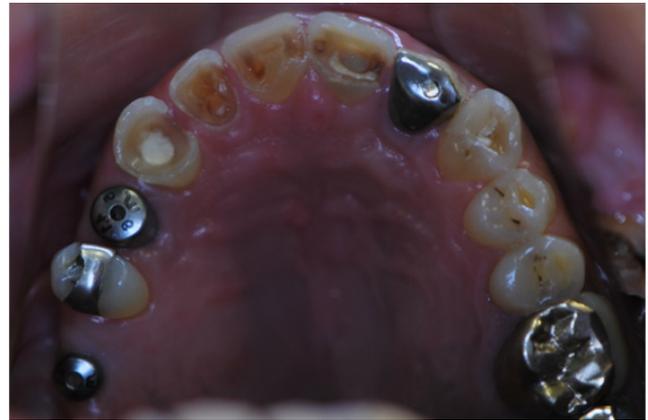
**Figure 2** - Occlusal view of upper arch showing signs of severe wear of teeth #23, #22, #21, #11, and #12; and light to moderate wear in teeth #13, #14, and #15

At intraoral examination, it was observed in the maxillary arch: the absence of third molars; teeth #16 and #17 with metal-ceramic crowns and unsatisfactory endodontic treatment; teeth #13, #14 and #15 with moderate wear; tooth #12 with core and crown; teeth #11, #21, and #22 with severe wear, and tooth #11 with endodontic treatment; tooth #23 with endodontic treatment and moderate wear; osseointegrated dental implants on the area of teeth #24, #26, and #27; tooth #25 with satisfactory MO amalgam restoration (figure 2). In the lower arch: osseointegrated implants on area of teeth #36, #37, #45, and #47; teeth #35-#43 all with severe wear and pulp vitality; tooth #44 with moderate wear, endodontic treatment and temporary restoration in restorative glass ionomer; tooth #46 with sharp coronal wear and endodontic treatment (figure 3).

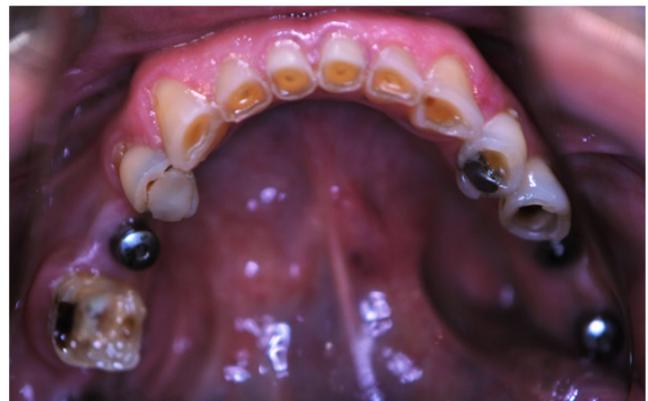
**Figure 3** - Occlusal view of lower arch showing severe wear anterior teeth; the "cupping" of lesions (concave aspect) in incisal and occlusal surfaces characterize the erosion occurred by GERD

After the clinical examination it was found that all implants had external hexagon joint and regular platform ( $\varnothing 4.1$  mm), duly osseointegrated and exposed to the oral environment through the use of healing abutments. The wear of tooth surfaces in concave appearance, demonstrated the erosive process, resulting from GERD, in the process of loss of tooth structure [1]. The parafunctional habits (bruxism) without the use of occlusal devices was appointed as the main reason for the severe wear of the teeth.

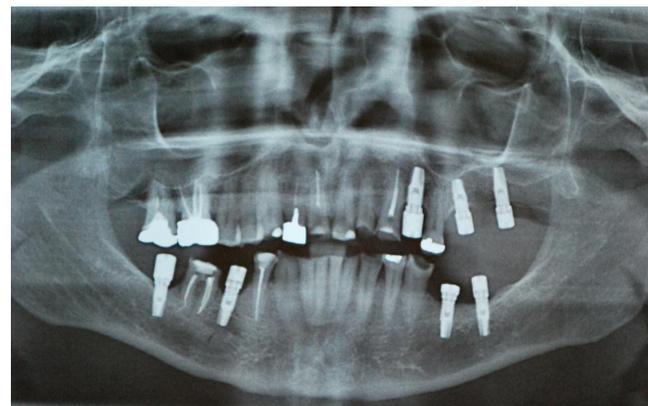
**Figure 4** - Panoramic radiography. Implants on the area of teeth #24, #26, #27, #36, #37, #45, and #47; endodontic treatment in teeth #11, #12, #16, #23, #44, and #46; crowns on teeth #16 and #17; core + crown on tooth #12, amalgam restoration on tooth #25 and glass ionomer cement restoration on teeth #11, #23, #44, and #26

A panoramic radiograph was requested to complement diagnosis. Thus, it was possible to analyze the bone insertion of teeth and implants as well as the quality of endodontic and restorative treatments (figure 4). At the extraoral examination, a loss of occlusal vertical dimension was found, being confirmed by the deepening of the nasolabial folds and reduced volume of lips (figures 5A and 5B).

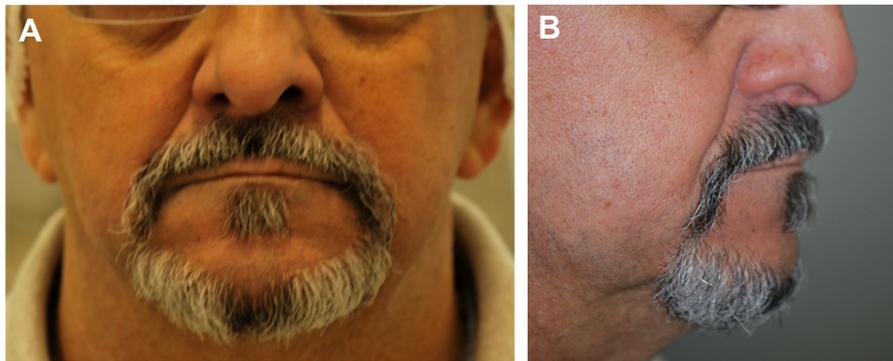
**Figures 5A and 5B** - Extraoral aspect. Frontal view (A) and lateral view (B) evidencing loss of lip volume and nasolabial folds depth by OVD reduction

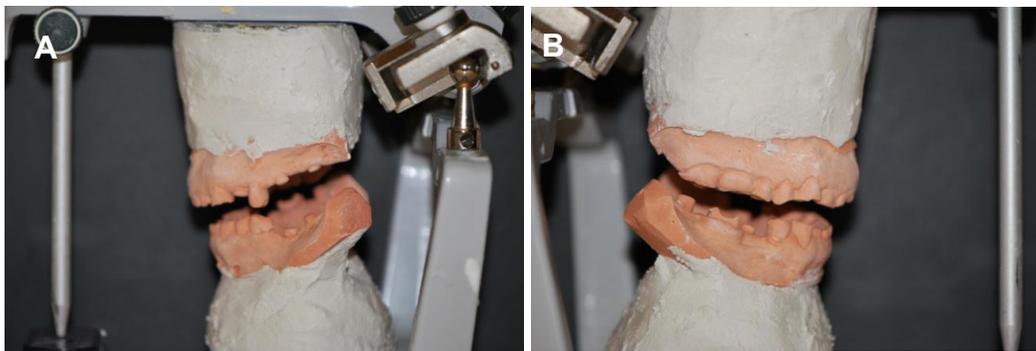
**Figures 6A and 6B** - Casts mounted on articulator at the reestablished OVD; left (A) and right sides (B)

bow was set up to assist the correct positioning of the models in the semi-adjustable articulator (SAA) and an occlusal registration was held with dense silicone, at OVD, measured by manipulating the patient in centric relation (CR) by Dawson's bi-manual technique. The articulator with mounted models (figure 6 A and B) was referred to the dental laboratory for the waxing of the teeth #16-#27, and #47-#37 (figures 7A, B and C).

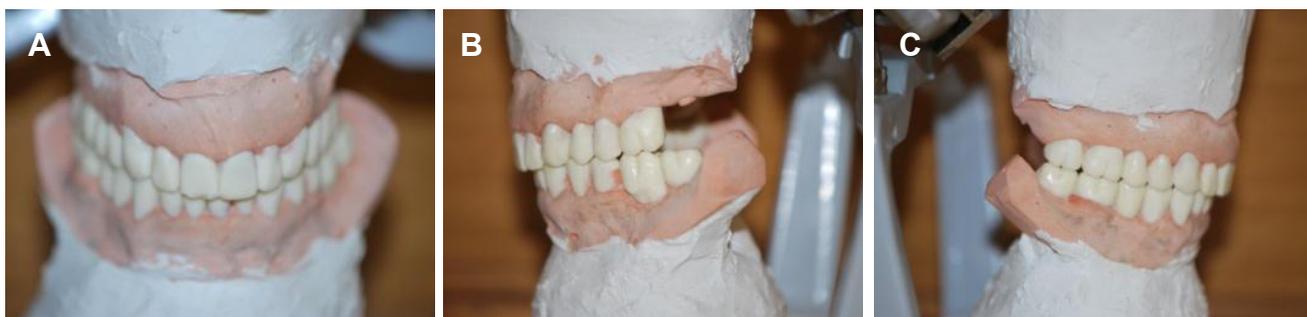
**Figures 7A, 7B and 7C** - Waxing from frontal (A), left side (B), and right side (C) view

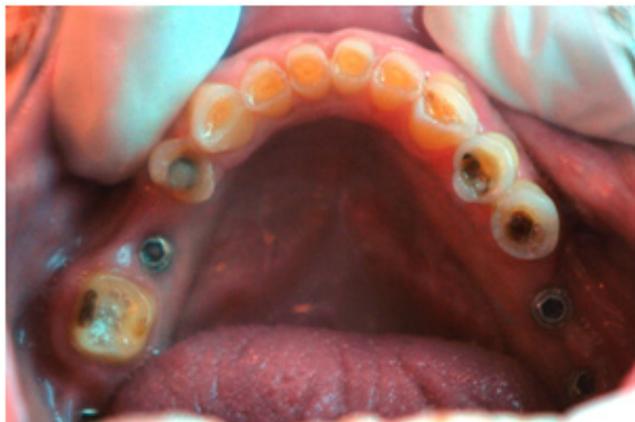
**Figure 8** - Lower arch (occlusal view) after preparation

In the lower arch, the tooth #36 was prepared for a metal-ceramic crown and tooth #35 tooth was prepared for an onlay ceramic crown. In the remaining teeth, just a plasty for regularization of the edges were made on the occlusal/incisal surfaces worn by parafunctional habit (figure 8).

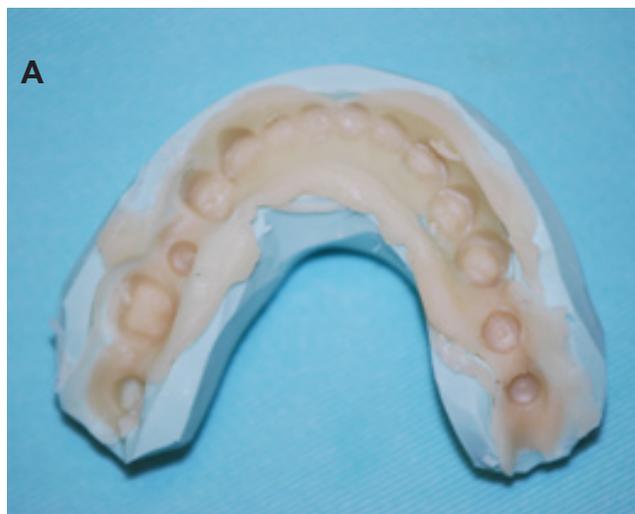
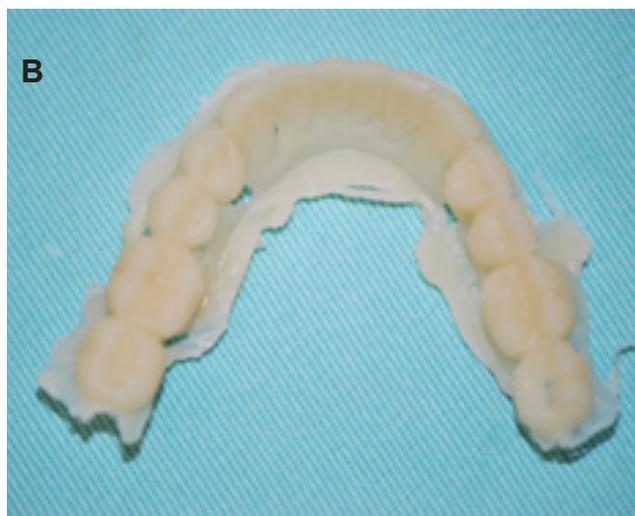
**Figures 9A and 9B** - A = Silicone matrix technique; B = Provisional prosthesis after its removal from silicone matrix before finishing procedure

The upper and lower waxing was then copied with a condensation silicone (Speedex; Coltène; Rio de Janeiro, Brazil) to perform provisional fixed prostheses by the silicone matrix technique. The acrylic resin (Dencor, Campo Limpo Paulista - SP, Brazil) was mixed at the ratio indicated by the manufacturer and inserted in the silicone matrix at the sandy phase stage. After the loss of brightness of the resin and the set of the silicone matrix and the acrylic resin, they were taken off the patient's mouth (figures 9A and 9B). This step was performed with the healing abutments in position to mark the placement of implants in the prosthesis. The excess was removed with tungsten cutters (maxicut and minicut), as well as serrated discs for removal of excess in the proximal regions.

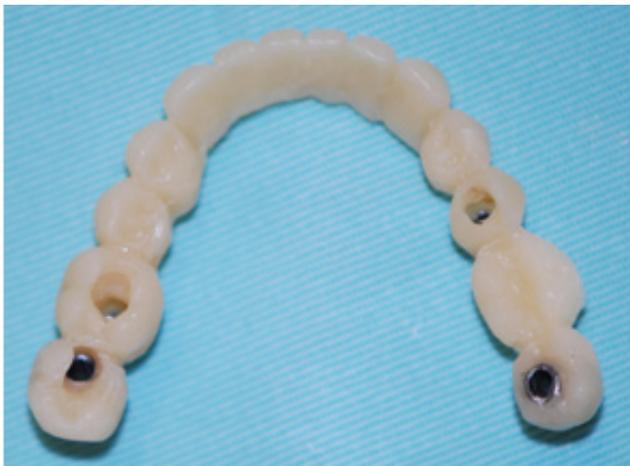
**Figure 10** - Provisional prosthesis with captured UCLA abutments and after the finishing and polishing procedure

of holes corresponding to the implant abutments in the prosthesis and four titanium UCLA abutments with anti-rotational device (UCLA HE titanium; Neodent; Curitiba-PR) were installed on the implants and cut at the occlusal plane level. Then, the UCLA abutments were captured, using the bead-brush technique to bond them to the prosthesis. Thus, the result for the lower arch was a single piece implant-retained fixed prosthesis, screwed onto the implants (37, 36, 45 and 47) and only supported by the remaining teeth (figure 10). The finishing and polishing process was performed with rubber and abrasive polishing paste with felt disc and Robinson brush (figure 11). Spaces were left in the gingival aspect to allow cleaning by the patient.

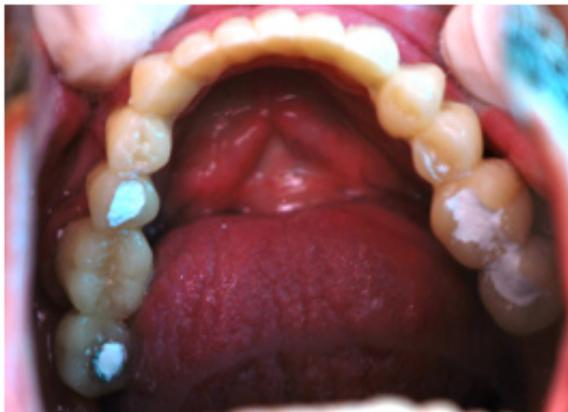
**Figure 11** - Aspect of lower arch after fixed prosthesis installation (occlusal view)

In seeking to seal the teeth/prosthesis interface, it was used glass ionomer cement (GIC) (Vidrion C, SS White, Rio de Janeiro - RJ, Brazil) to avoid marginal leakage and reduce sensitivity of worn teeth. This material was chose due to its capability to release fluoride.

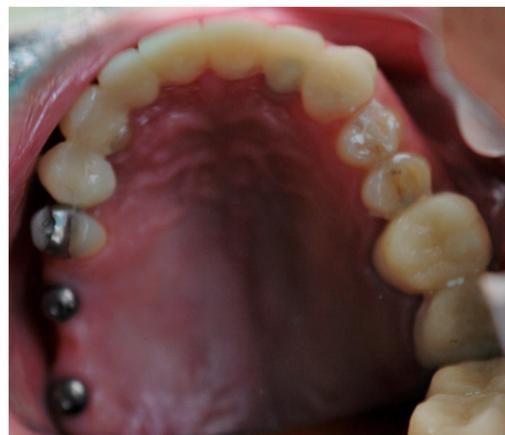
**Figure 12** -Prostheses installed in upper arch (teeth #16 and #17; #13 to #24), teeth #14 and #15 received and increasing of resin composite on occlusal surface to reestablish the occlusal contact

In the upper arch, two provisional prostheses were constructed, one joining the teeth #16 and #17, and the other extending from the teeth #13 to #24, cemented over the prepared tooth #12 and the prepared titanium abutment on the implant of tooth #24; and just leaning on teeth #13, #11, #21, #22, and #23 with GIC liner used for sealing the interface between them and the provisional prosthesis (figure 12). The finishing and polishing procedures were performed in the same manner described for the lower arch.

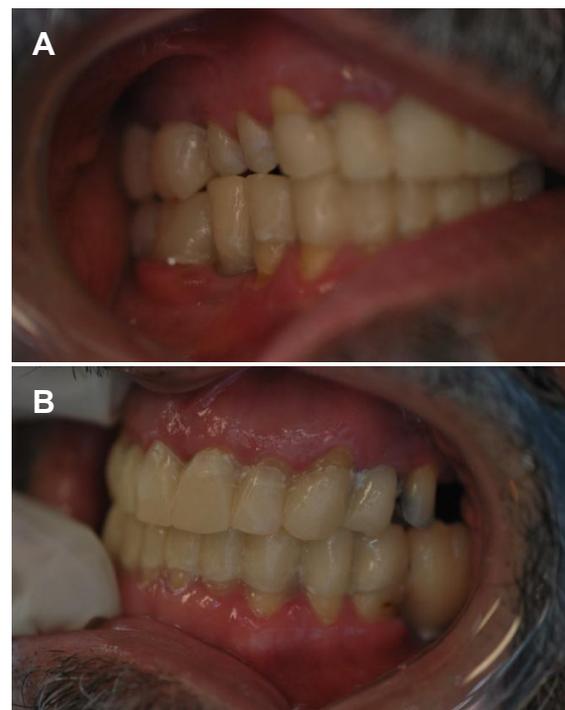
**Figures 13A and B** - Final aspect from right (A) and left side (B) showing reestablished occlusal contacts

The hygiene instruction was performed after the provisional prostheses installation. After 15 and 30 days, maintenance was done to evaluate the occlusal condition and hygiene. Temporary occlusal acetate splint (BIOART, San Carlos - SP, Brazil) was constructed for the upper arch, aiming at the protection of the prosthetic work and avoid the deleterious effects of bruxism. Figures 13A, 13B, 14, 15A and 15B shows the provisional prostheses finished installed on patient's mouth.

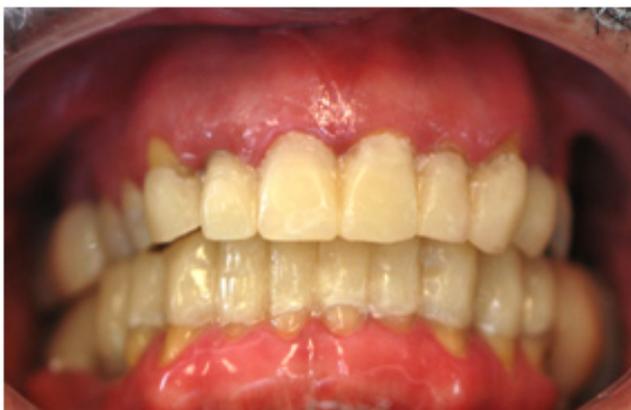
Figure 14 - Final aspect from frontal view

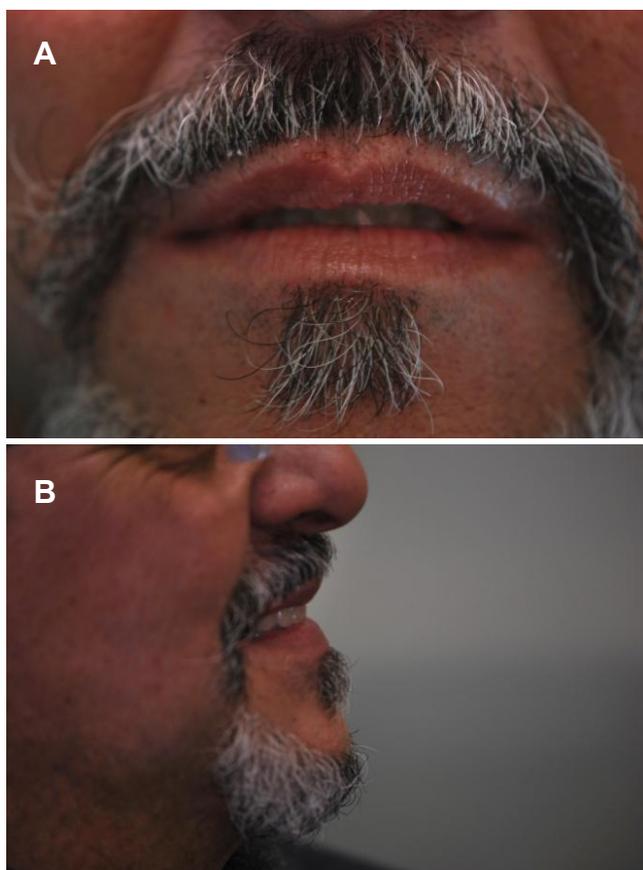
Figures 15A and B - Final aspect from frontal (A) and lateral (B) view showing the OVD, lip support, and smile aesthetics reestablished
